# Report on Post Tsunami Survey along the Myanmar Coast for the December 2004 Sumatra-Andaman Earthquake

**Abstract:** The tsunami heights from the 2004 Sumatra-Andaman earthquake were between 0.4 and 2.9 m along the Myanmar coast, according to our post tsunami survey at 22 sites in Ayeyarwaddy Delta and the Taninthayi coast. Interviews to coastal residents indicate that the tsunami arrived between 2 to 5.5 hours after the earthquake, although nobody felt ground shaking. Much smaller tsunami than the neighboring Thai coast, where the tsunami heights were 5 to 20 m, explains relatively slighter tsunami damage in Myanmar; the casualties were reported as 71, compared to about 8300 in Thailand. The smaller tsunami was probably due to the fact that the tsunami source did not extend to Andaman Islands. The tsunami travel times and maximum heights computed from a 700 km long source are basically consistent with the observation. For a nearby tsunami source, the tsunami hazard would be more significant in Myanmar, because coastal houses are unprotected for tsunamis and no infrastructure exists to disseminate tsunami warning information.

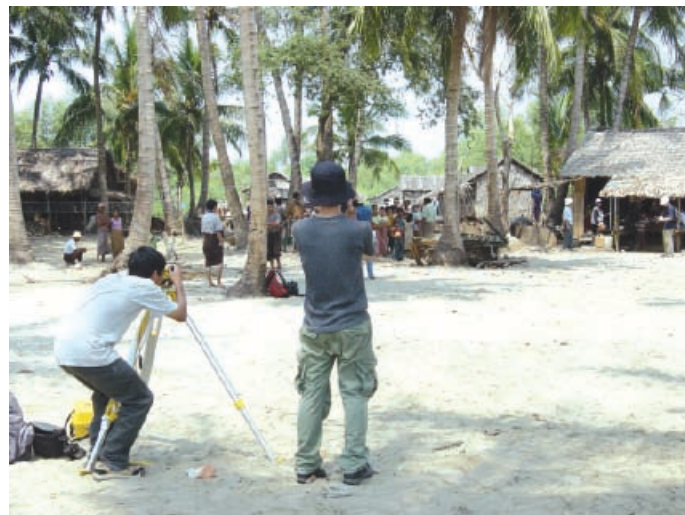
In order to measure the tsunami heights, we used a handheld laser ranging instrument (Impulse 200LR; Laser Technology Inc.) and an auto-level equipment (Photo 1). In general, auto-level with the tripod provides more accurate heights than the laser instrument without the tripod, while the laser instrument provides quicker results for a long distance ( $>100$  m). For measurements of a short distance, we used both instruments. The vertical difference between them is at most 20 cm. For measurements of longer distance, we used only laser instrument.

Photo 1. Two kinds of measurements, using auto-level (left) and laser (right) instruments.

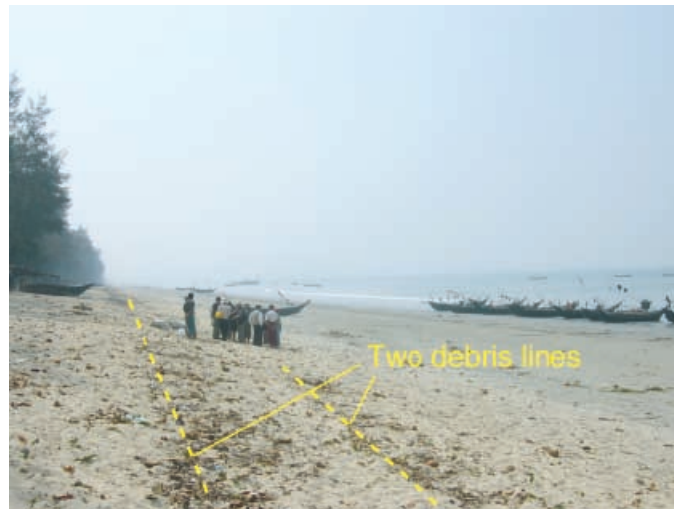
On this beach, two parallel lines of debris were observed (Photo 2). A local fisherman (36 years old male) told us that the lower debris line was formed by the December tsunami. He did not feel the earthquake but observed that the tsunami arrived at around 2 pm, in a total of four successive waves with 3 to 4 m height. The tsunami arrived at low tide and did not exceed the high tide level of the rainy season (the higher debris line). Another eyewitness indicated the tsunami arrival times were between 10 am and 12 noon.

Our measurement at 10:27 on March 7, 2005 indicates that the lower and higher debris lines are 2.4 m and 2.9 m above the sea level at the time of measurement (Photo 2). The dune, to which the tsunami did not reach, was 4.0 m high. The corrected tsunami height, assuming that the tsunami arrived at 11:00, becomes 1.8 m.

Photo 2. Group interviewing local people who had observed tsunamis at Maungmagan Beach, MM-01 (looking south).

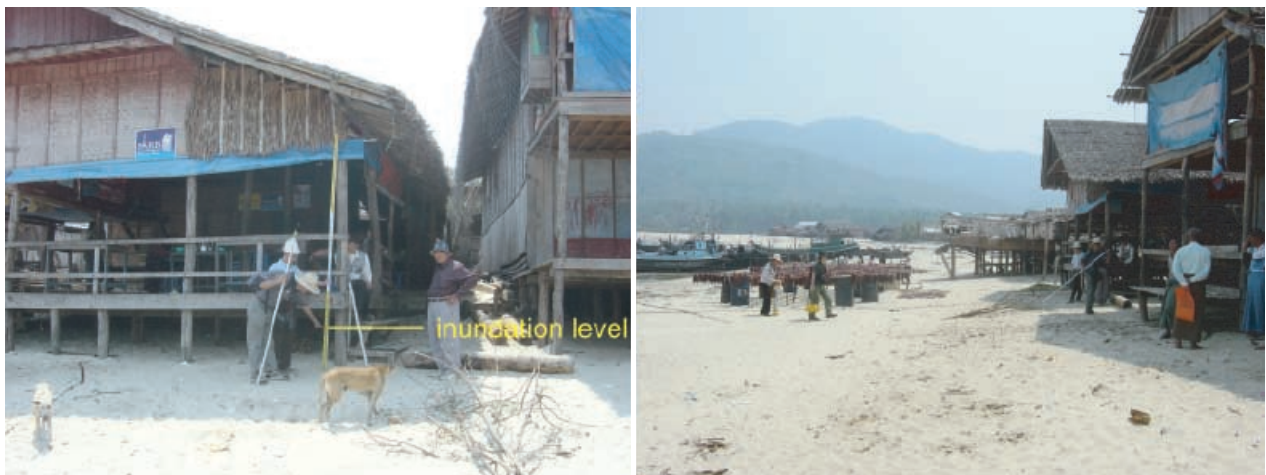
Thabawseik-Kyauksent Village is a coastal village of about 200 houses which builds up very close to the shore line. The peoples' stable earning is mainly fishery. The interview with a local person (51 year old male) confirmed that the tsunami reached up to 55 cm above the ground (Photo 3 left) and arrived between noon and 1 pm in three successive waves of 20 minute intervals but caused no severe damage. The tsunami height was lower than the rainy season high-tide level. The measurement at 11:25 on March 7 indicates that the tsunami height was 2.4 m above the sea level, while rainy season high tide level was 3.0 m. The corrected tsunami height becomes 1.6 m.

Photo 3. Survey measurement at Thabawseik-Kyauksent Village. Arrow indicates the height of tsunami (pointed by interviewee).

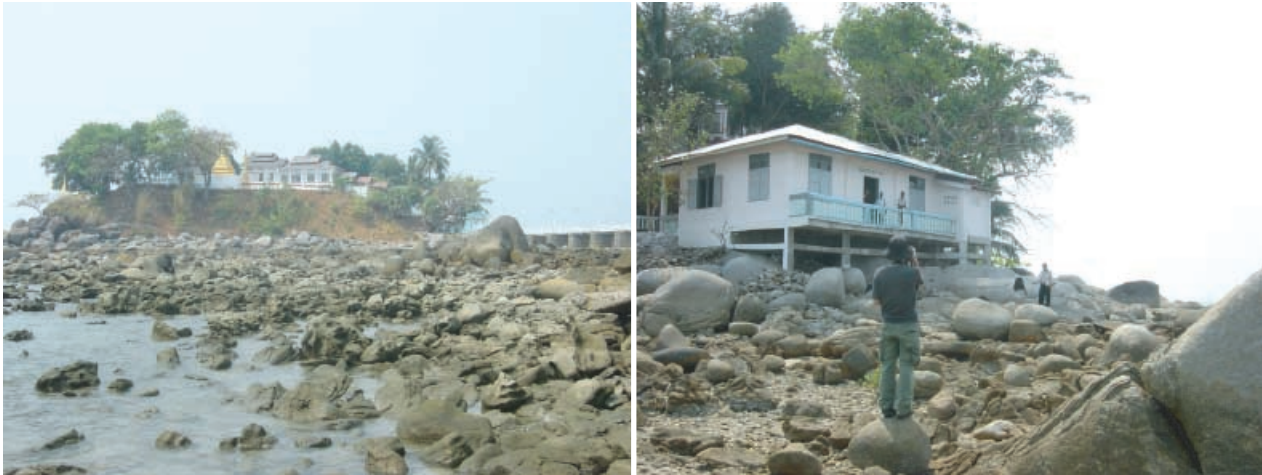
Myaw Yit Gyi Pagoda is situated on a small granite island and connected to the opposite bank by a concrete bridge (Photo 4). A Buddhist monk from the Pagoda told us that he did not feel the earthquake shaking. Between 9:30 and 11:30 am, he observed that three waves coming from different directions reached at the base of the bridge. The height of tsunami was larger than the high tide of the rainy season. When receded, the seafloor was exposed about 200 m from the shore line.

The measurement at 13:56 on March 7, 2005 indicates that the tsunami height was 3.3 m above the sea level. The corrected tsunami height becomes 1.4 m.

Photo 4. Interview with a Buddhist monk at Myaw Yit Gyi Pagoda (left) and view of Myaw Yit Gyi pagoda in seaward (westward) direction (right).

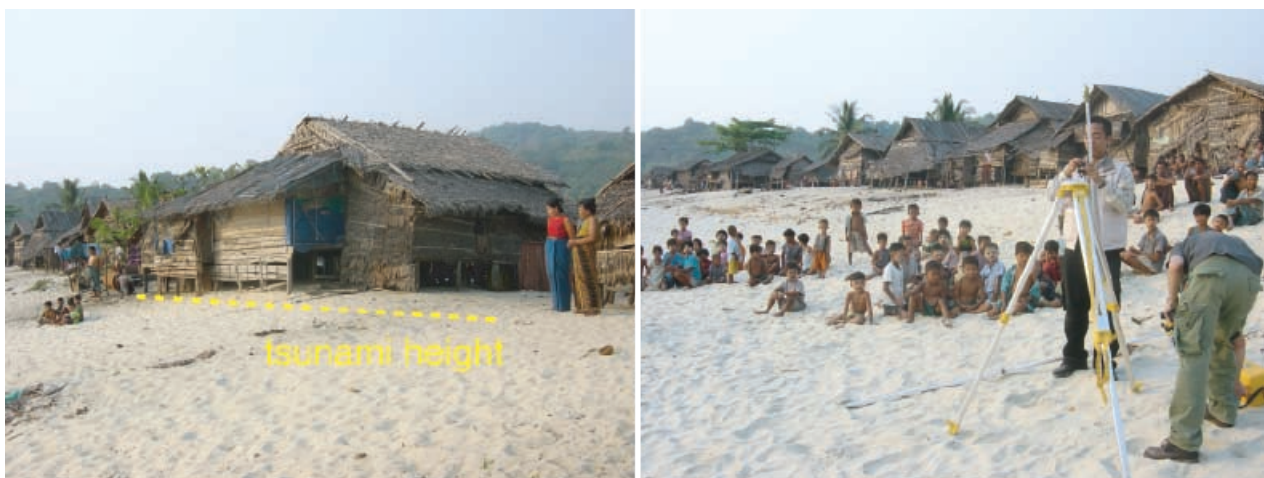
Sann Lan Village is also situated on the same shore line, and constituted of almost wooden houses. The major earning is fishery. A fisherman told that the tsunami arrived at 11 am in four times with 15 minute intervals and it was coincidence with low tide (Photo 5).

Measurement at 16:40 on March 7, 2005 indicates that the tsunami height was 4.9 m above the sea level, while the high tide of the day was between 1.9 and 2.3 m. The corrected tsunami height becomes 2.9 m.

Photo 5. Survey at Sann Lan Village. Yellow dotted line is tsunami height (left). Measurement at Sann Lan Village (right).

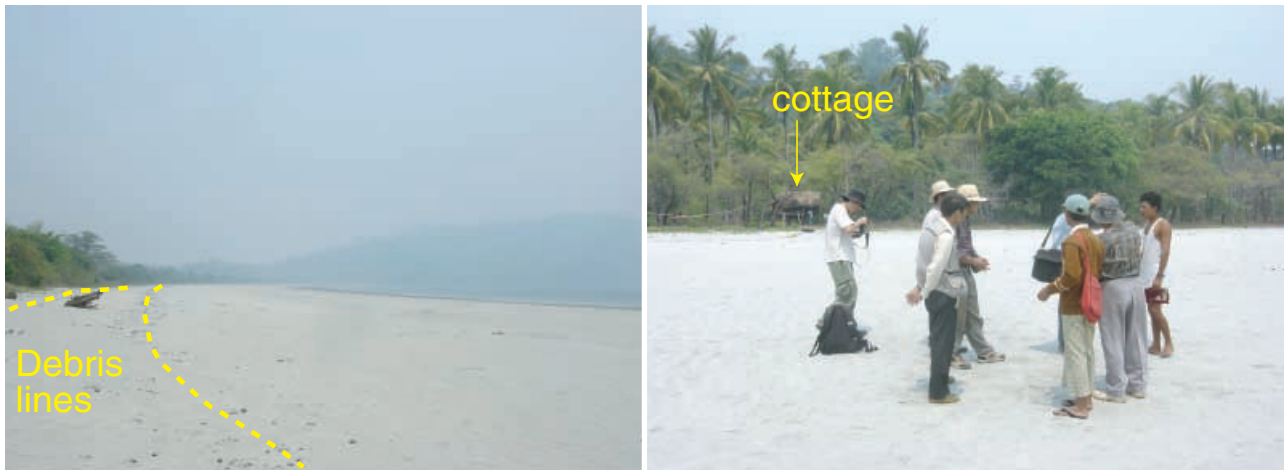
Kyet Lut beach is situated on the southern tip of the peninsula, 60 km from the Dawei. Two parallel debris lines were observed on the beach (Photo 6 left). A 19-years old male who live in a cottage where a group of farmers living seasonally reported that the tsunami entered after lunch (normally, local people take lunch about 10 am), and observed three times with 3 to 5 minute intervals. In addition, the lower debris was brought by the tsunami, while the upper one was by rainy season high tide.

Measurement at 12:30 on March 8, 2005 indicates that the lower debris line was 2.7 m above the sea level, while the upper line was 3.2 m. The corrected tsunami height becomes 1.9 m.

Photo 6. Survey at Kyet Lut Beach. Debris line indicates the maximum reach of tsunami (left) and a small seasonal hut where the interviewee lives (right).

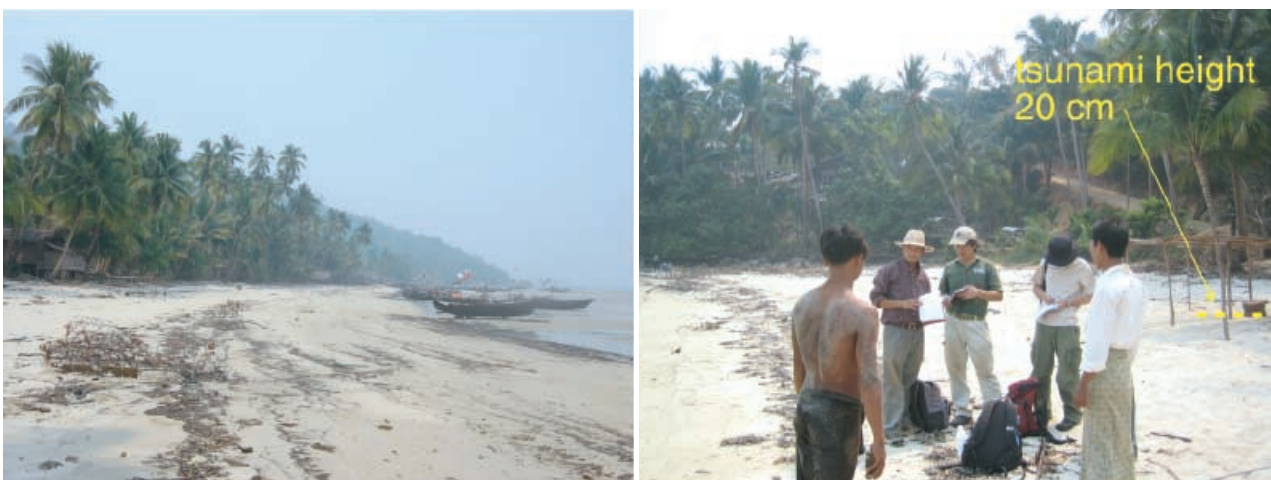
Photo 7. Survey at Kyaukmattat Village on the west bank of the Dawei River.

Kyaukmattat Village is situated on the west bank of the Dawei River and the major earnings of the people are farming and fishery. A fisherman mentioned that a receding wave firstly came around 1 pm and then another high tide appeared at 8 pm. He indicated that the tsunami height was about 20 cm above ground on the wooden structure (Photo 7 right).

Measurement at 14:00 on March 8, 2005 indicates that the tsunami height was 2.6 m above the sea level. The indicated high tide levels of the day and rainy season were 2.3 m and 3.8 m, respectively. The corrected tsunami height becomes 0.9 m.

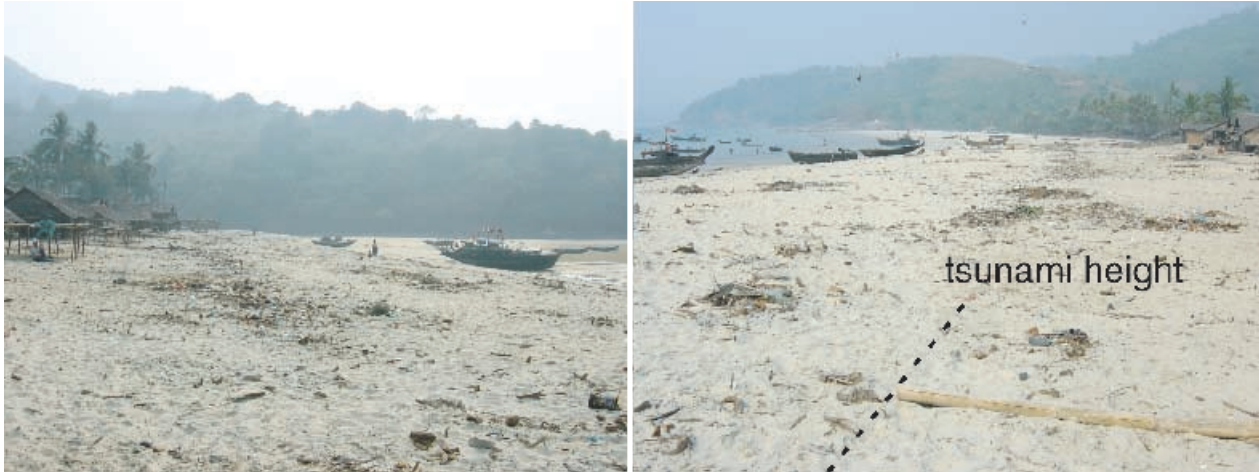
Photo 8. Survey at Nyawbyin Village in Longlon Township.

Nyawbyin Village is situated on the western coast of the peninsula in Longlon Township and its curve shape beach profile is surrounded by two ridges. Most people did not feel the earthquake but noticed that the tsunami arrived there around noon.

The measurement at 15:07 on March 8 indicates that the tsunami height was 4.3 m above the sea level. The indicated high tide levels of the day and rainy season were 3.2 m and 4.8 m, respectively. The corrected tsunami height becomes 2.0 m.

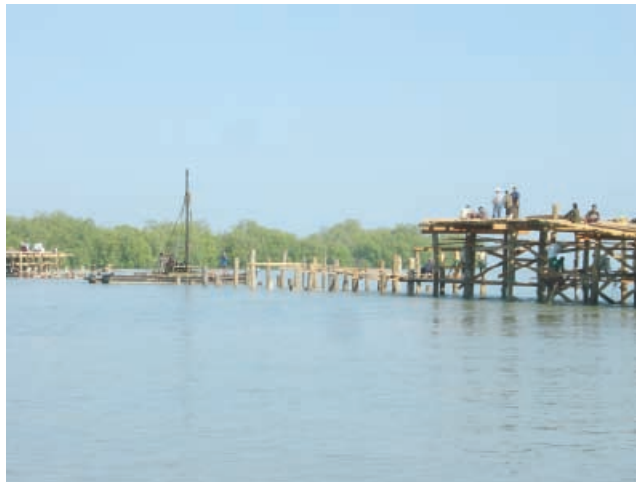
Plautonton Island is a small island close to the west coast of Kawthaung City, connected by a 600 meter long wooden bridge. The central part of the bridge was destroyed by the tsunami (Photo 9). Field survey was taken at Plautonton Village on the island. Most houses of the village are built on a mudflat, raising floor level up to one or two meters above the sea surface (Photo 10 left). Watermarke was observed at the interviewee's house (Photo 10 right). A 37 year old housewife told that the tsunami arrived at 10:30 am in three waves with 15 minute intervals. A 62 year old male, owner of a grocery store, said that two waves with 10-15 minute intervals arrived. Because the tsunami arrived during low tide, there was no severe damage to buildings, but some household wares (rice bags, cloths and TV sets, etc) were flooded. One person died in this village.

Photo 9. Destruction of wooden bridge to Plautonton by the tsunami.

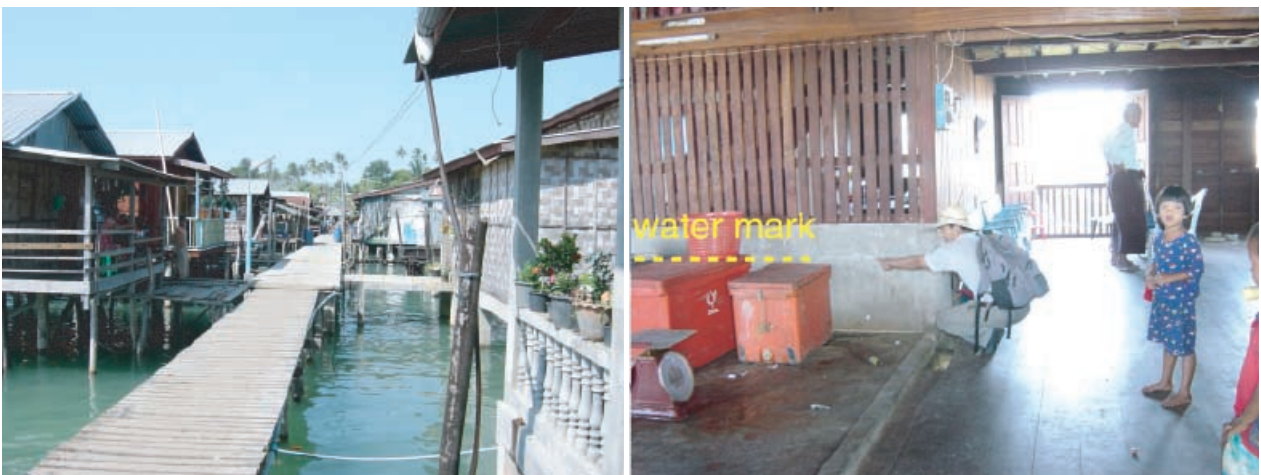
Photo 10. Houses above water (left) and the watermark on the wall of a house (right).

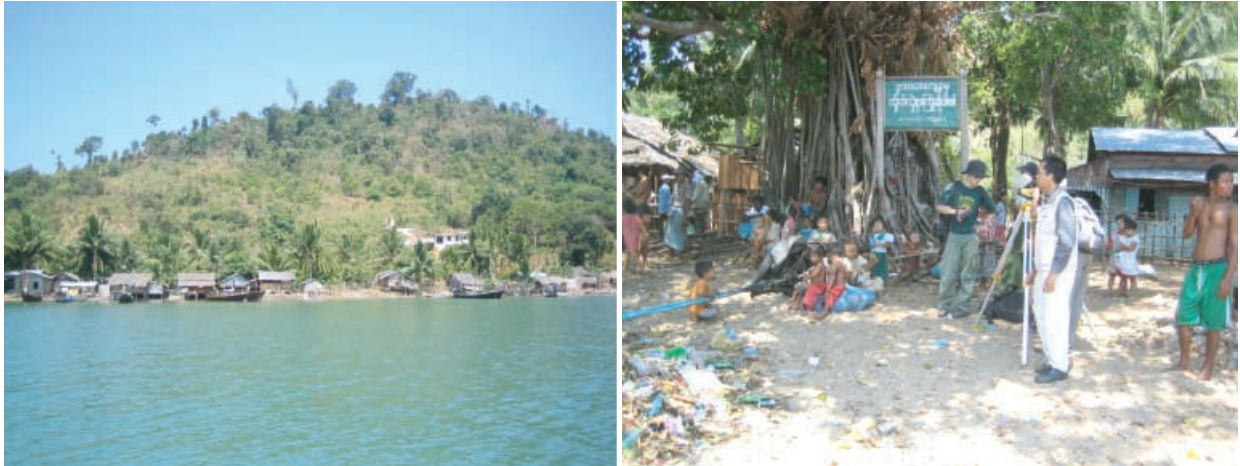
Photo 11. Field survey at Ywarthaya Village, Salonlay Island.

At the Ywarthaya Village of Salonlay Island, situated to the west of the Plautonton Island, there was no damage at all by the tsunami (Photo 11). A 23 year old male told us that the tsunami arrived at 11:15 am. Three to four waves arrived with 5 minute intervals. Measurement (at 10:50 March 10) indicates that the tsunami height was 1.0 m above the sea level, while the rainy season high tide level was 0.6 m. The corrected height is 1.8 m.

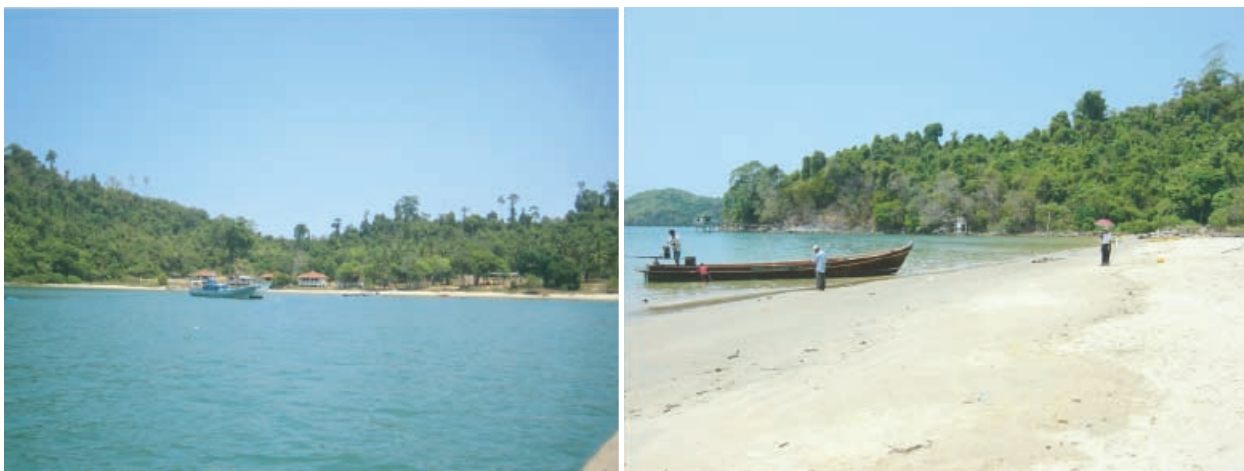
Photo 12. Survey at the Dolphin Club, Salon Island.

The Dolphin Club of Salon Island, a few kilometers south of Salonlay Island, has a flat shore line. An interview was made to an eyewitness from the Dolphin Club. A 27 year old male told us that tsunami arrived at 11:45 am, in four waves with 5 minute intervals, and the height was the same as the sea level at the time of our visit at 11:40 on March 10. The high tide level in rainy season is 1.1 m above the sea level. The corrected height is 0.4 m (Photo 12).

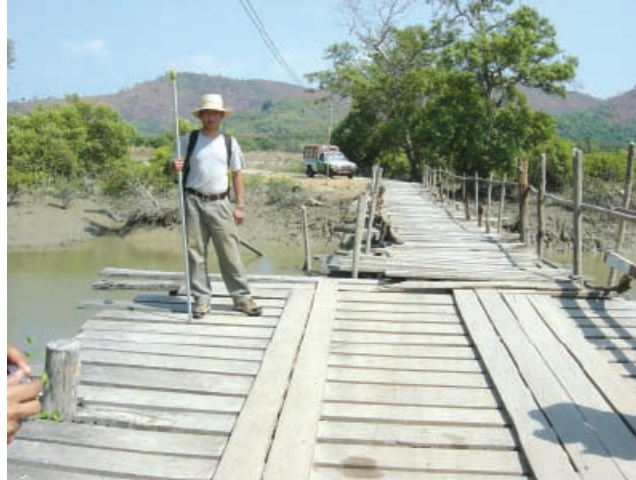
Konnamaing Chaungwa is a small village located on the western coast, northwest of Kawthaung City. A bridge over a stream connected to the village was partly damaged during the incoming tsunami (Photo 13).

Photo 13. Destruction of bridge to Konnamaing Chaungwa Village by tsunami (narrow flat portion in the right far site of photo).

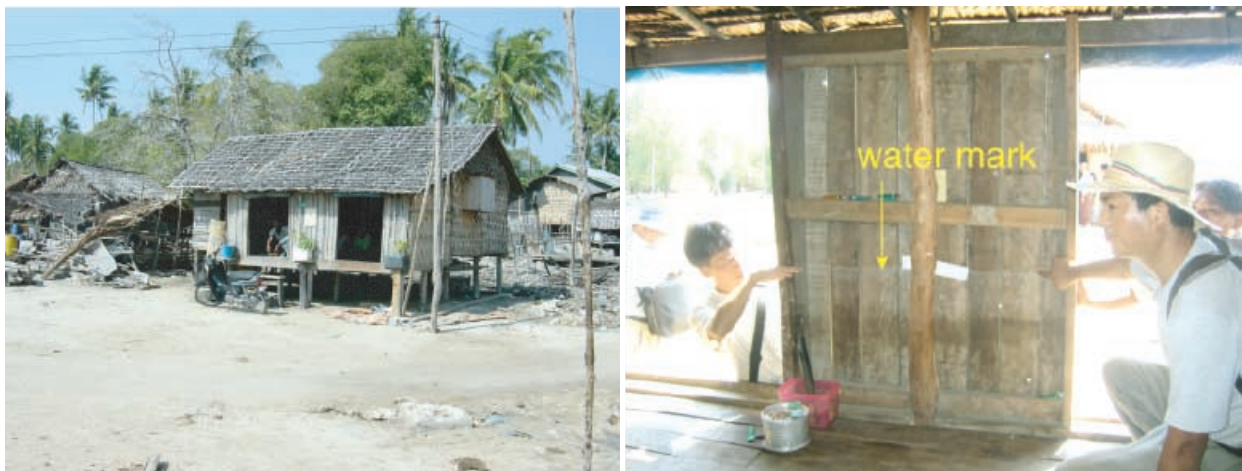
There were some damages by the tsunami: one death and destruction of eight houses. There is a clear watermark on a wall of a house indicating the tsunami height (Photo 14 right). Furthermore, the tsunami brought up some fishing boats along the stream course and then onto the paddy field (Photo 15 left). Some traces of marine mud on telephone post indicated the height of splash from the tsunami (Photo 15 right). According to eyewitness account, the tsunami arrived at 10:45 am.

Systematic measurement at 14:40 on March 10, 2005 indicates that the two watermarks were 1.4 and 1.2 m above the ground level, and 3.9 m and 4.0 m above the sea level. The corrected tsunami height is 1.9 m.

Photo 14. Watermark (right) at the wall of the interviewee's house (left).

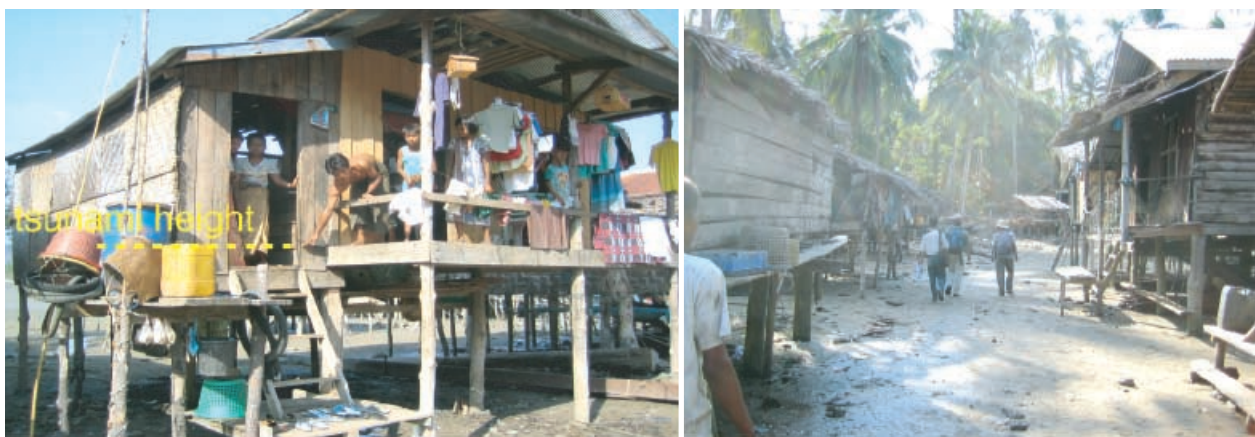
Photo 16. Field survey at Tannyopada.

Tannyopada is a small village of 40 houses located along the shore line northwest of Kawthaung City. A 40 year old man told that the tsunami arrived between 10:30 and 11:00 am, in three times with 10 minute intervals (Photo 16).

The measurement at 15:50 on March 10 indicates that the tsunami height was 4.4 m above the sea level. The sea level was very low at the time of measurement and the current water front was more than 200 m offshore, hence the height measurement was less reliable. The corrected tsunami height becomes 1.7 m.

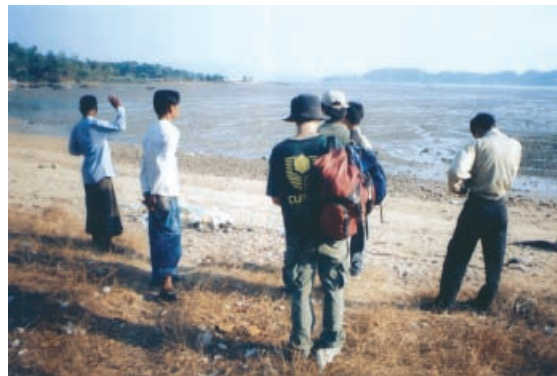
Measurement at 16:54 on March 10 indicates that the tsunami height was 3.3 m above the sea level. The calculated tide levels at the time of measurement and 11:00 of December 26 are 0.2 m and 2.9 m, respectively, hence the corrected height would be 0.6 m. However, the sea level at the time of measurements was very low, and the measured heights are not reliable. Alternatively, we estimate the tsunami heights using the differential levels at this location. We also measured, on the basis of eyewitness accounts, the high tide levels of the rainy season, evening and morning of the day as 2.0 m, 1.8 m and 1.5 m, respectively, above the sea level. The tsunami height was 1.8 m higher than the high tide level of the morning of March 10. The calculated high tide is 3.7 m, or 0.8 m higher than 11:00 of December 26. From these, the tsunami height is estimated as 2.6 m. We consider that this estimate is more reliable.

Photo 17. Field measurement was carried out in Thirimyaing Quarter of Kawthaung City. A large coverage of mud flat in connection with low tide and a barrier of Island in the seafront lead to less tsunami effect on the shore.

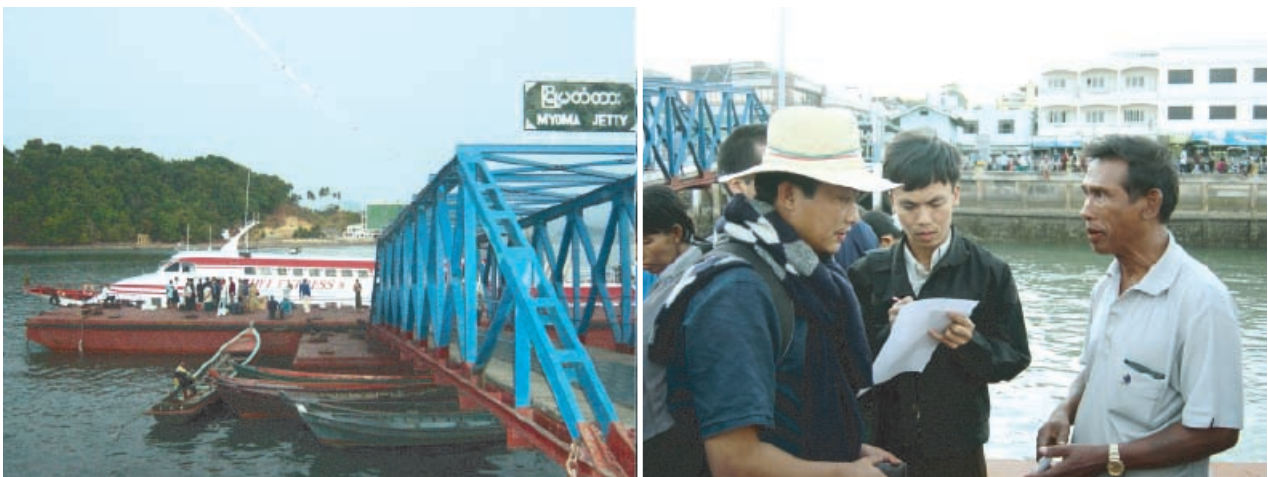
Photo 18. Survey at Kawthaung Myoma Jetty.

Myoma Jetty is a harbor for domestic transportation near the center of Kawthaung City. Many people noticed the abnormal rise of sea level and reported that the highest tsunami level was about 30 cm below the top of the quay wall (Photo 18).

Measurement at 17:30 March 10 indicates that the tsunami height was 4.1 m above the sea level. The estimated tsunami height becomes 1.6 m.

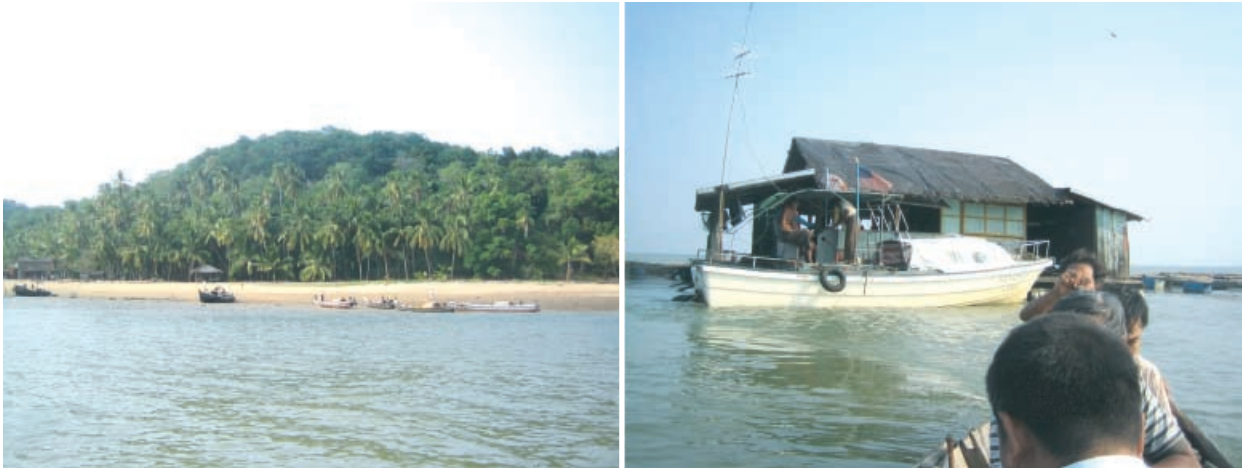
Photo 19. Field survey at Thandar Kyun Village.

Survey was taken at Thandar Kyun Village about 10 km west of Myeik City (Photo 19). A 27 year old male told that the tsunami arrived at 11 am, in two waves with 20 minute interval.

Our measurement (at 16:10 March 11) of the tsunami levels of two accounts are 2.2 m and 4.4 m, and the high tide level of the rainy season is 5.1 m. Assuming that the higher level (4.4 m) represents the maximum tsunami height and the tsunami arrival time as 11:00 am, the corrected height becomes 0.7 m.

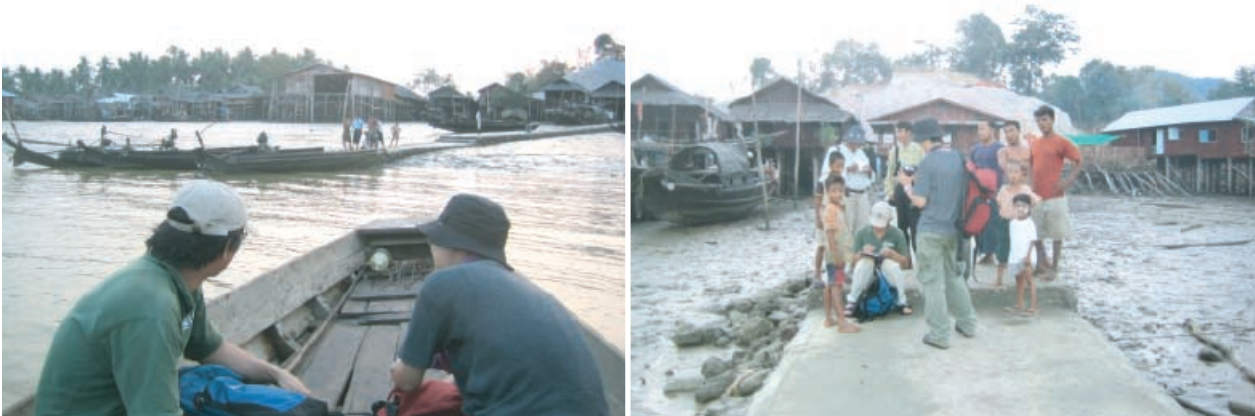
Photo 20. Field survey at Pahtaw Village.

Pahtaw Village is located on a small island, a few kilometers west of Myeik City. An eyewitness reported that the tsunami arrived at 12 noon in three waves (Photo 20 right).

Measurement (at 18:00 March 11) indicates that the tsunami height was 6.7 m above the sea level, while the high tide in the rainy season was 6.3 m. Assuming that the tsunami arrival time was 11:00, the corrected tsunami height becomes 2.2 m. An eyewitness indicated that the tide level just before the tsunami arrival was 4.6 m, making the tsunami height 2.1 m, very similar to the corrected height.

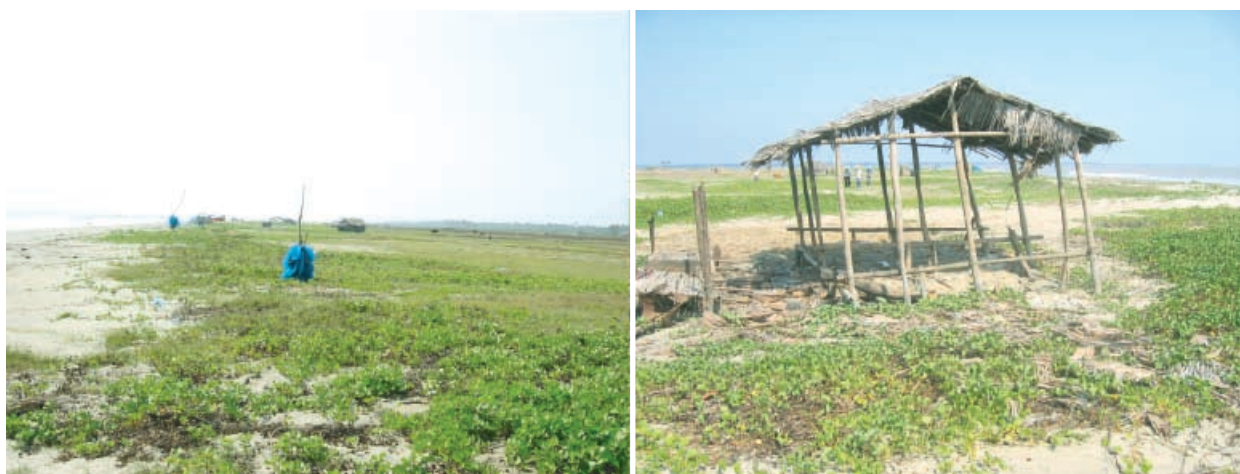
Photo 21. Field survey at Layyin Kwin (Airfield) Village near Pyinsalu.

At Layyin Kwin Village, 16 huts out of 20 were washed away and one person was perished by the tsunami. According to an eyewitness, the tsunami arrived at 11:45 am, when the tide was low, in four waves. The inundation depth was about 20 cm.

Measurement at 14:46 on March 13, 2005 indicates that the tsunami level was 0.7 m above the sea level. Assuming that the tsunami arrived at 11:30, the corrected tsunami height becomes 0.6 m.

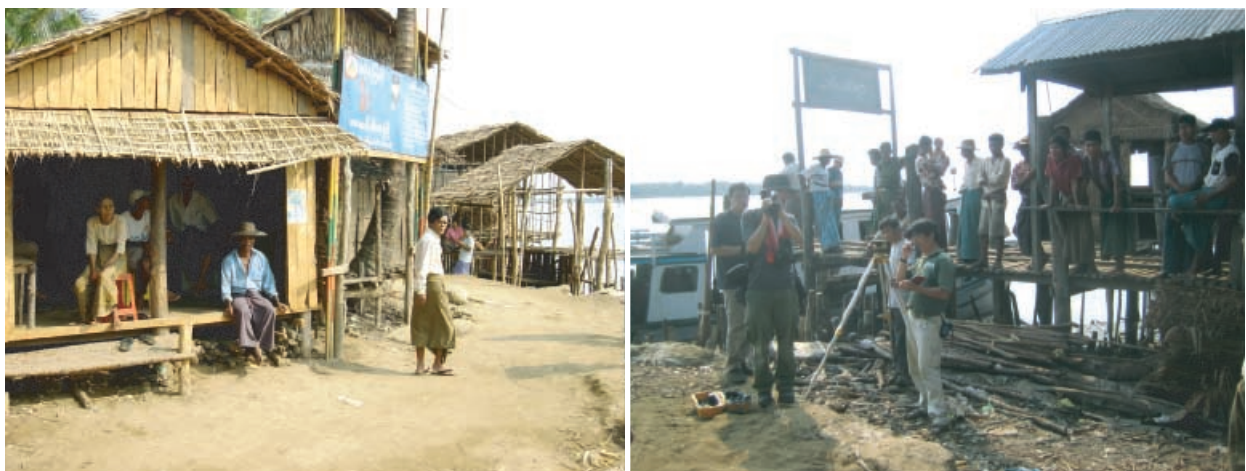
Photo 23. Field survey at Thit Poke Village.

Thit Poke Village is a small one with 332 houses and located at about 20 km from Pyinsalu. Two houses were damaged, but the tsunami caused no injuries or casualties. Interview with local people indicated that the tsunami inundated about 50 cm above the ground at 11:40 am. Measurement at 8:57 on March 14 indicates that the tsunami height was 2.9 m above the sea level. Assuming that the tsunami arrived at 11:30, the corrected height becomes 1.7 m.

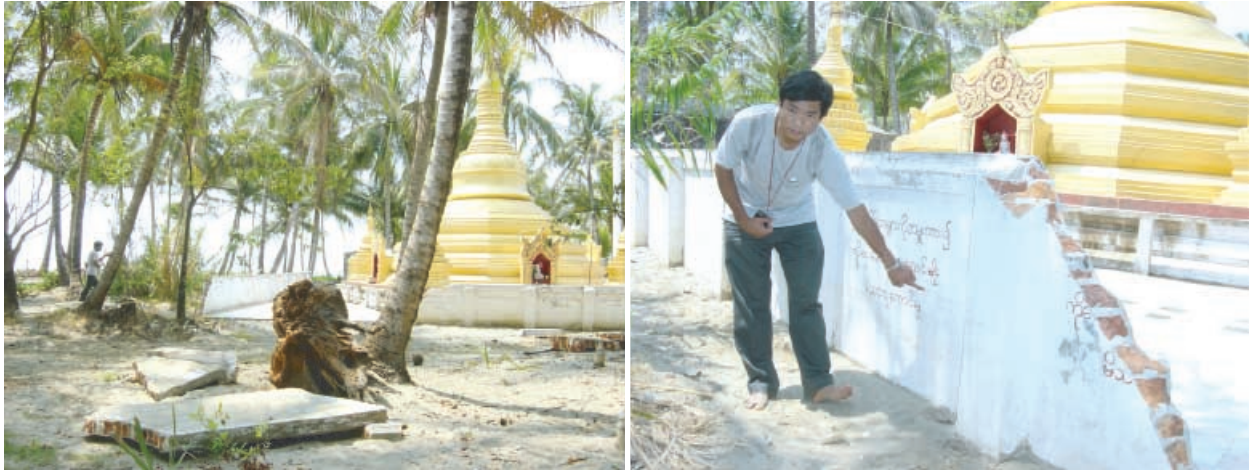
In Kaing Thaung Village, a pagoda built near the shore line was damaged by the tsunami. Part of the outer wall was knocked down (Photo 24 left) and watermark was clearly observed at 50 cm above the ground level (Photo 24 right). A Buddhist monk told us that the tsunami arrived at 11:30 am. Our measurement at 11:46 on March 14 indicates that the tsunami height was 1.8 m above the sea level. Assuming that the tsunami arrived at 11:30, the corrected height becomes 1.9 m.

Photo 24. Field survey at Kaing Thaung Island Pagoda. Walls of Pagoda are destructed by Tsunami (left) and Watermark at the wall (right).

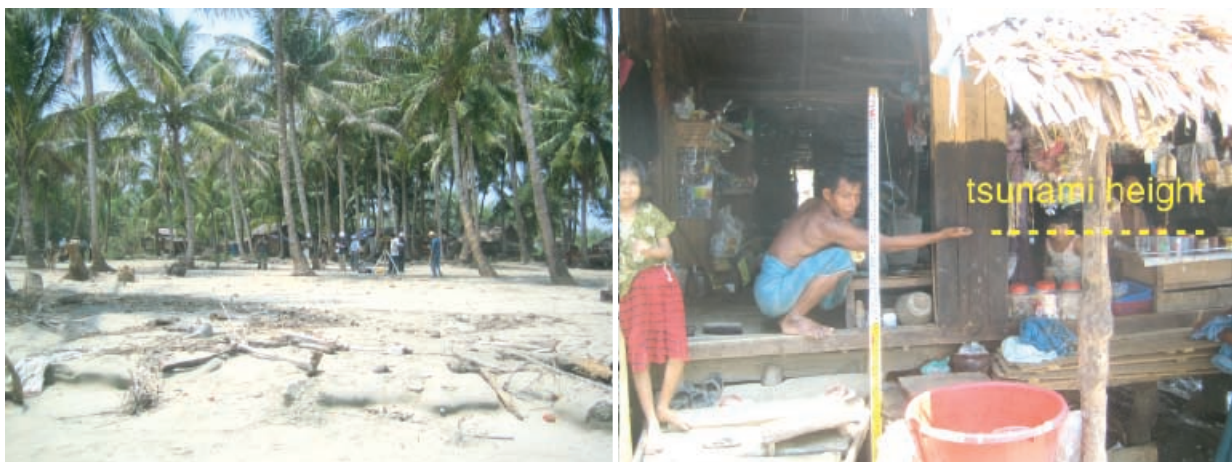
In the village, 8 casualties and 16 damaged houses are reported by Department of Meteorology and Hydrology. An eyewitness account indicated that the tsunami height was 1.35 m above the ground (Photo 25). Measurement at 12:05 on March 14 indicates that the tsunami height was 2.0 m above the sea level, and the corrected tsunami height is 2.3 m.

Photo 25. Field survey at Kaing Thaung Island Village. Local people showed the inundation height of tsunami wave (right).

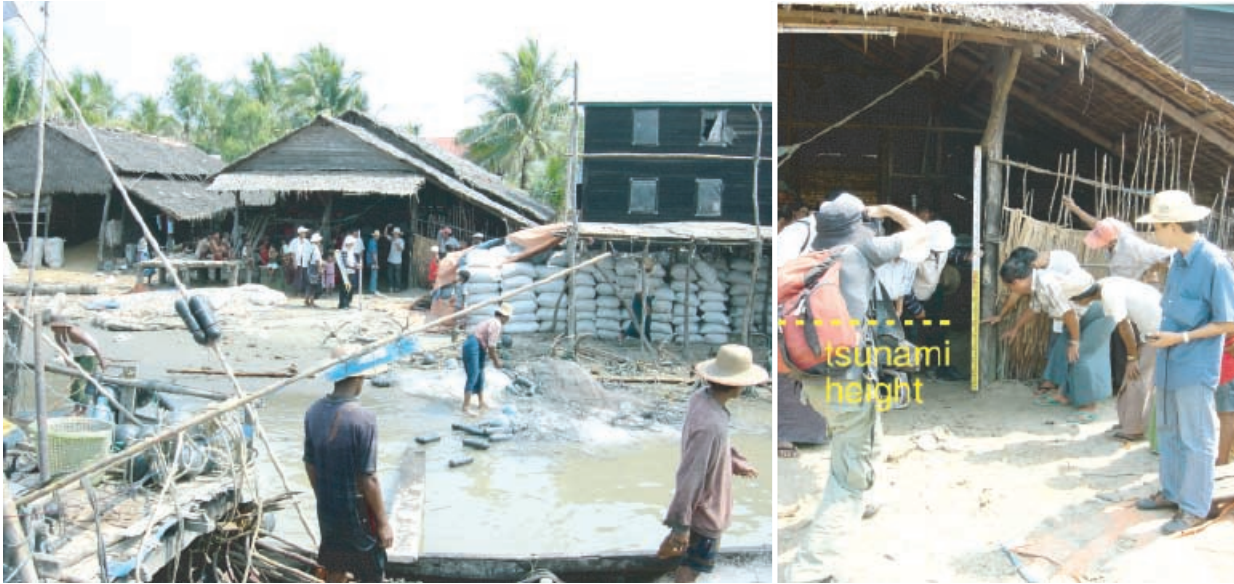
In Aung Hlaing Village, an eyewitness account indicated that the tsunami arrived at 11:45 am in two waves. The tsunami inundated about 60 cm above the ground (Photo 26 right). The second wave caused damage to 55 houses without any fatalities. Measurement at 14:06 on March 14 indicates that the tsunami height was 1.2 m above the sea level. Assuming that the tsunami arrived at 11:30, the corrected height becomes 1.5 m.

Photo 26. Survey at Aung Hlaing Village.
