Earthquake-related Groundwater Level Changes in a Sensitive Well

Ching-Yi Liu¹, Pei-Ling Wang ¹, Yeeping Chia¹, Wan-Yun Ho¹, Yen-Tsu Lin², Yen-Chun Kuan³

¹Department of Geosciences, National Taiwan University

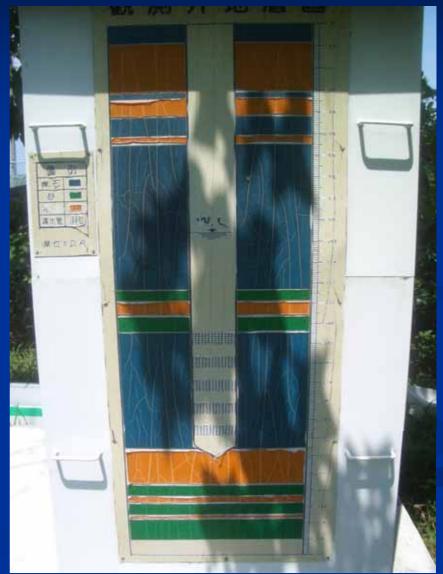
- ◆ PD-1
- 8 Active fault No.
- Active fault

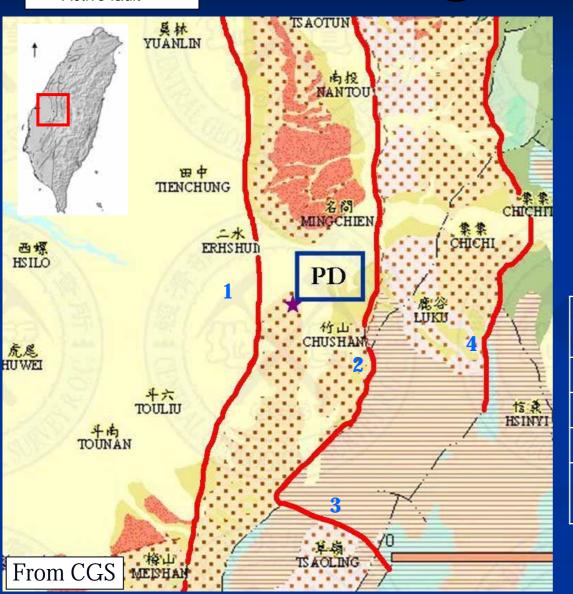
Geological Structuer

- Choshui River Alluvial Fan
- Dou-Liou hill
- Anticline

Fault name	Distance (Km)
1	Changhua Fault	5.4
2	Chelungpu Fault	6.2
3	Gukeng Fault	12.4
4	Damaopu- Shuangtung Fault	15.8

- The PD-1 well water level is sensitive to earthquakes.
- The process of coseismic change took from less than 1 hr to more than 2 hrs.
- The well water level declined 5 cm immediately before a 22 cm coseismic rise due to the 2000 M₁ 6.7 earthquake.
- Located at the fold axis and near several active faults.
